Digital photogrammetry: a standard approach to cultural heritage survey

DIGITAL PHOTOGRAMMETRY: A STANDARD APPROACH TO CULTURAL HERITAGE SURVEY

Andrea Lingua^a, Paolo Piumatti^b, Fulvio Rinaudo^a

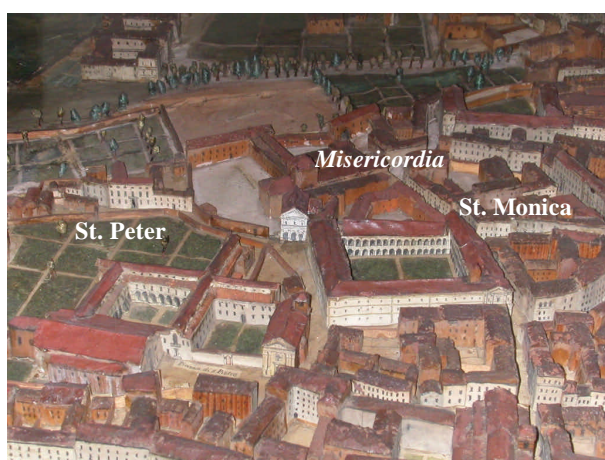
Figure 1. Urban hand made 3D model (M. Nicolosino, 1815) showing the church and the surrounding religious buildings (Local Museum of Savigliano)

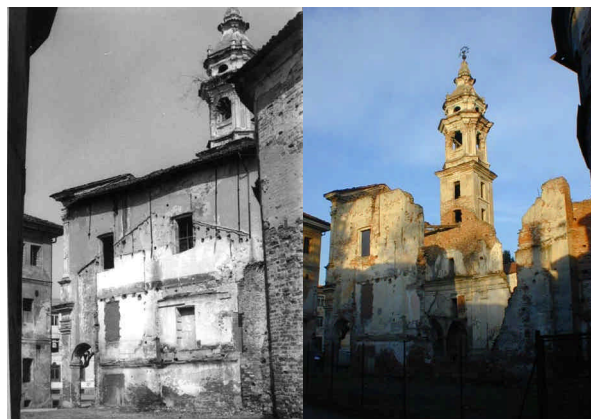
Figure 2. The church before and after the damage of 1984

Since then *Croce Nera* church has been a ruin: the roof, the vaults and part of the flanks and the apse have collapsed. The area where the church stands is still off-limits (see Fig. 2).

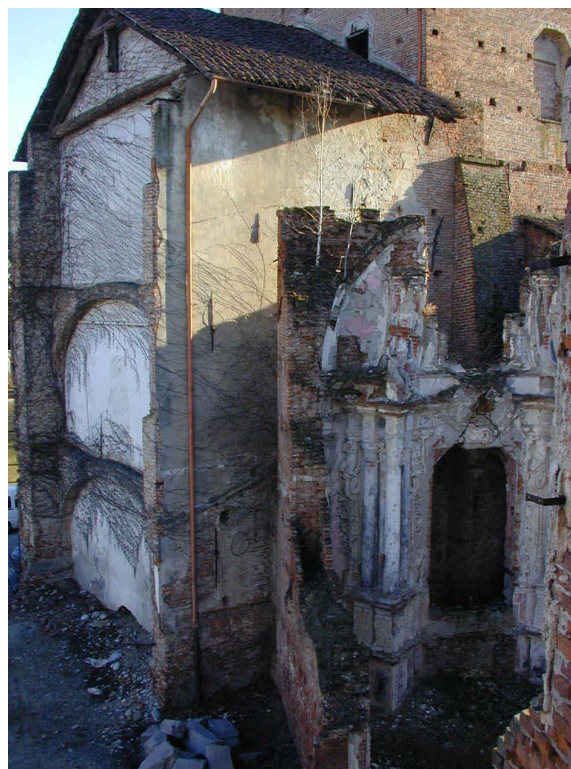
Figure 3. Rests of the vaults

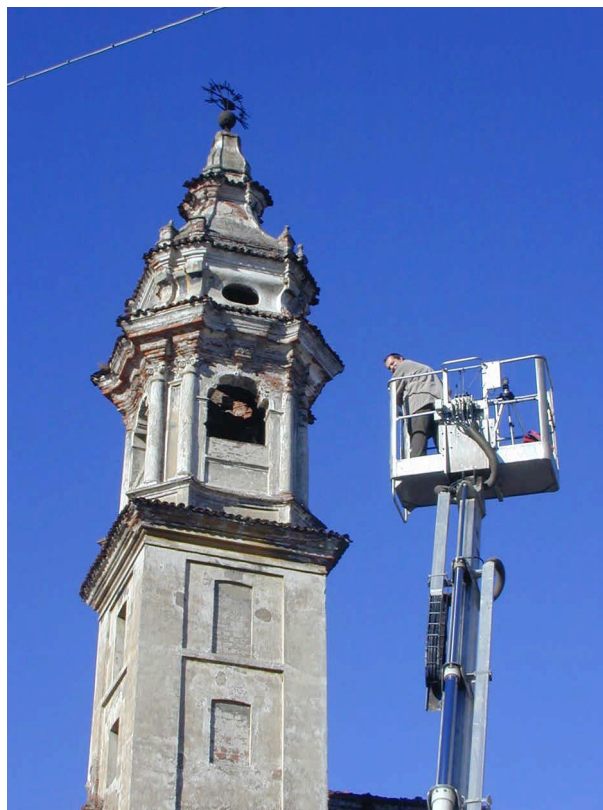
Figure 3. Photogrammetric taken of the bell tower

The images have been acquired by means of the semimetric ROLLEI 6008 camera ($f = 40$ mm): the scales of the images range from 1:800 to 1:400. In order to avoid perspective occlusions all the images have been recorded in the normal case of the photogrammetry. The images of the top parts of the buildings have been acquired by using "ad hoc" solutions (see Fig. 3).

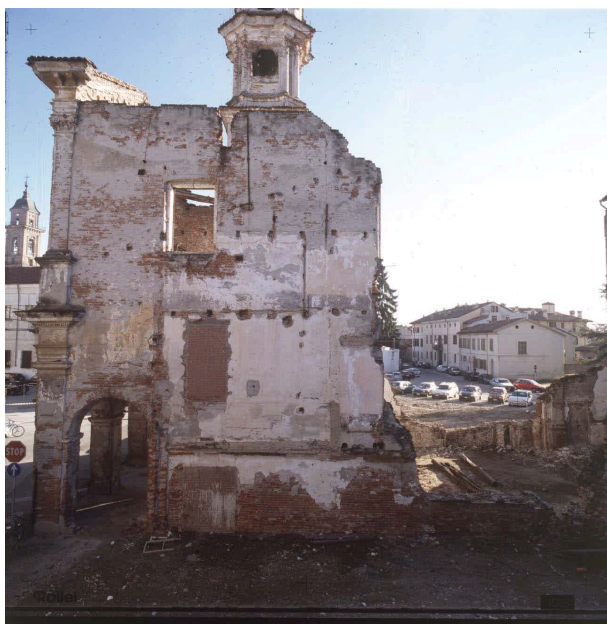
Figure 4. Semimetric image of the church

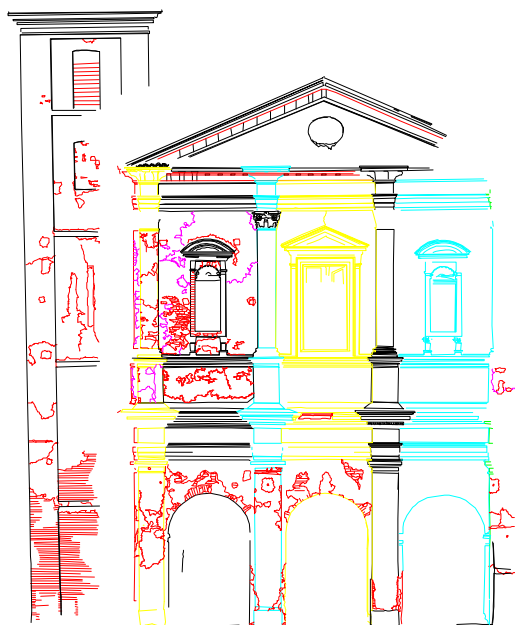
Figure 5. Plotting results of the main façade

30 of the 70 acquired images have been used during the restitution of the church. More than 25 logical levels of information have been used during the collection of the geometric data. Figure 5 shows the results of the plotting executed on the main façade of the church: different colours demonstrate the interpretation and classification performed during the restitution by the operator.

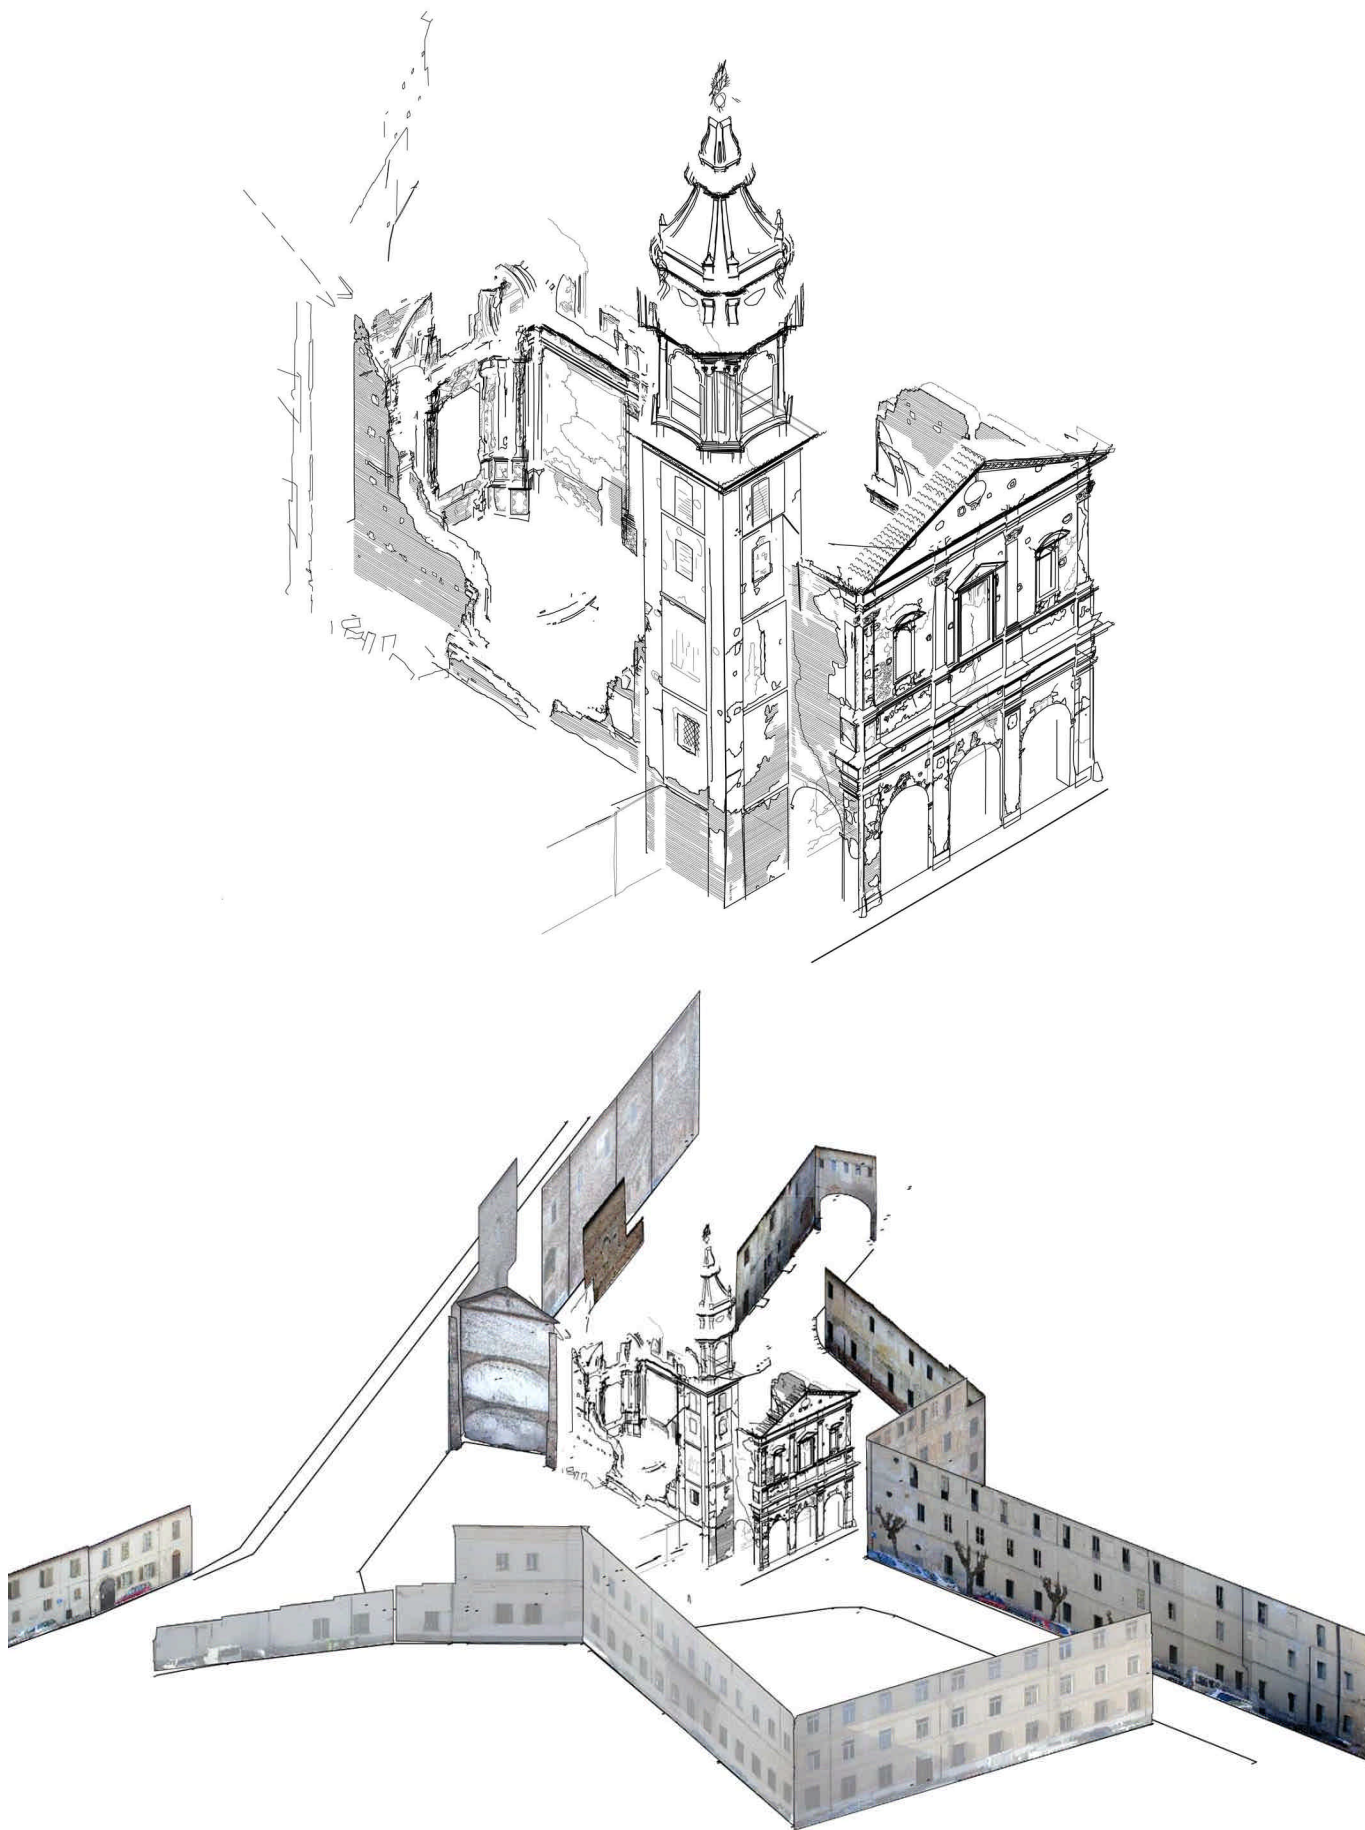
Figure 6. 3D models generated by the use of plotting and rectification results (drawing by Paolo Piumatti)

The representation of the results has been done both with digital and analogue (tables on paper) technology (see figures 6 and 7).

During the drawing assembly, both of the 3D and 2D models, different types of lines have been used in order to highlight different aspects: 0.4 mm thick lines for sections, 0.2 mm thick lines for principal visible elements, 0.13 mm thick lines for degradation, fissures, holes, missing bricks and rear elements and 0.05 mm thick black or grey lines for decorations and background elements.

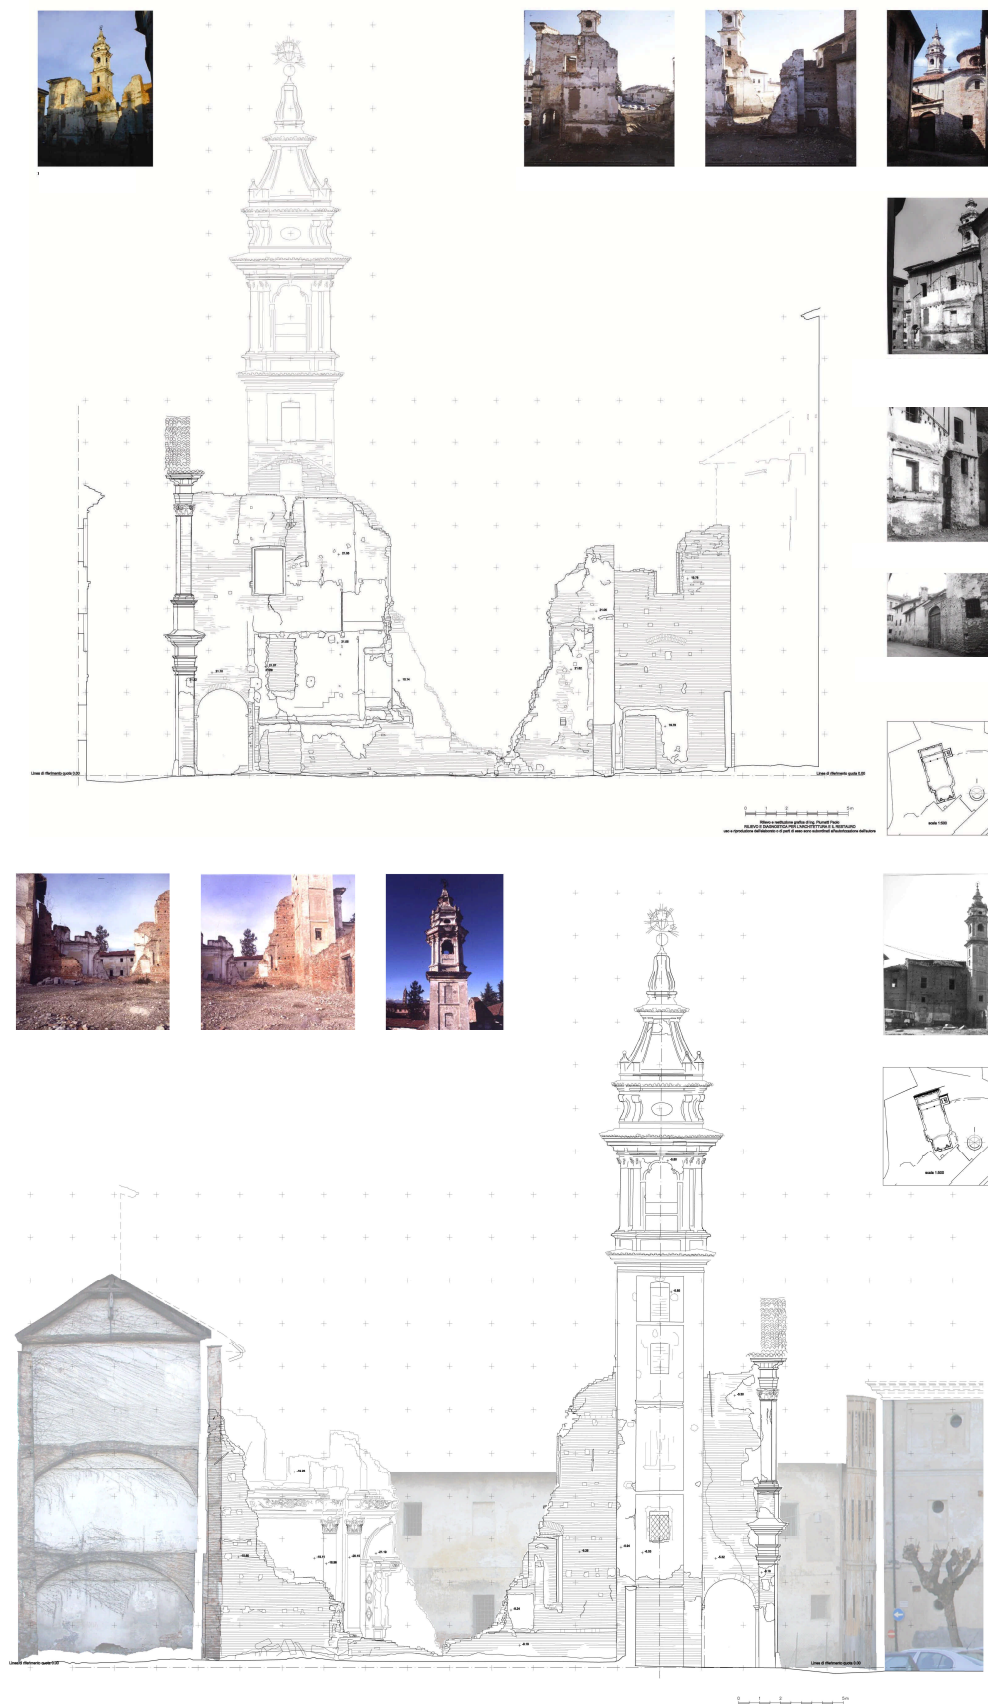
Figure 7. 2D representation of the results: photogrammetric survey, rectified images and photographic documentation (drawing by Paolo Piumatti)
